Typical Defects in Elastomeric Expansion Joints

Bridge Expansion Joints

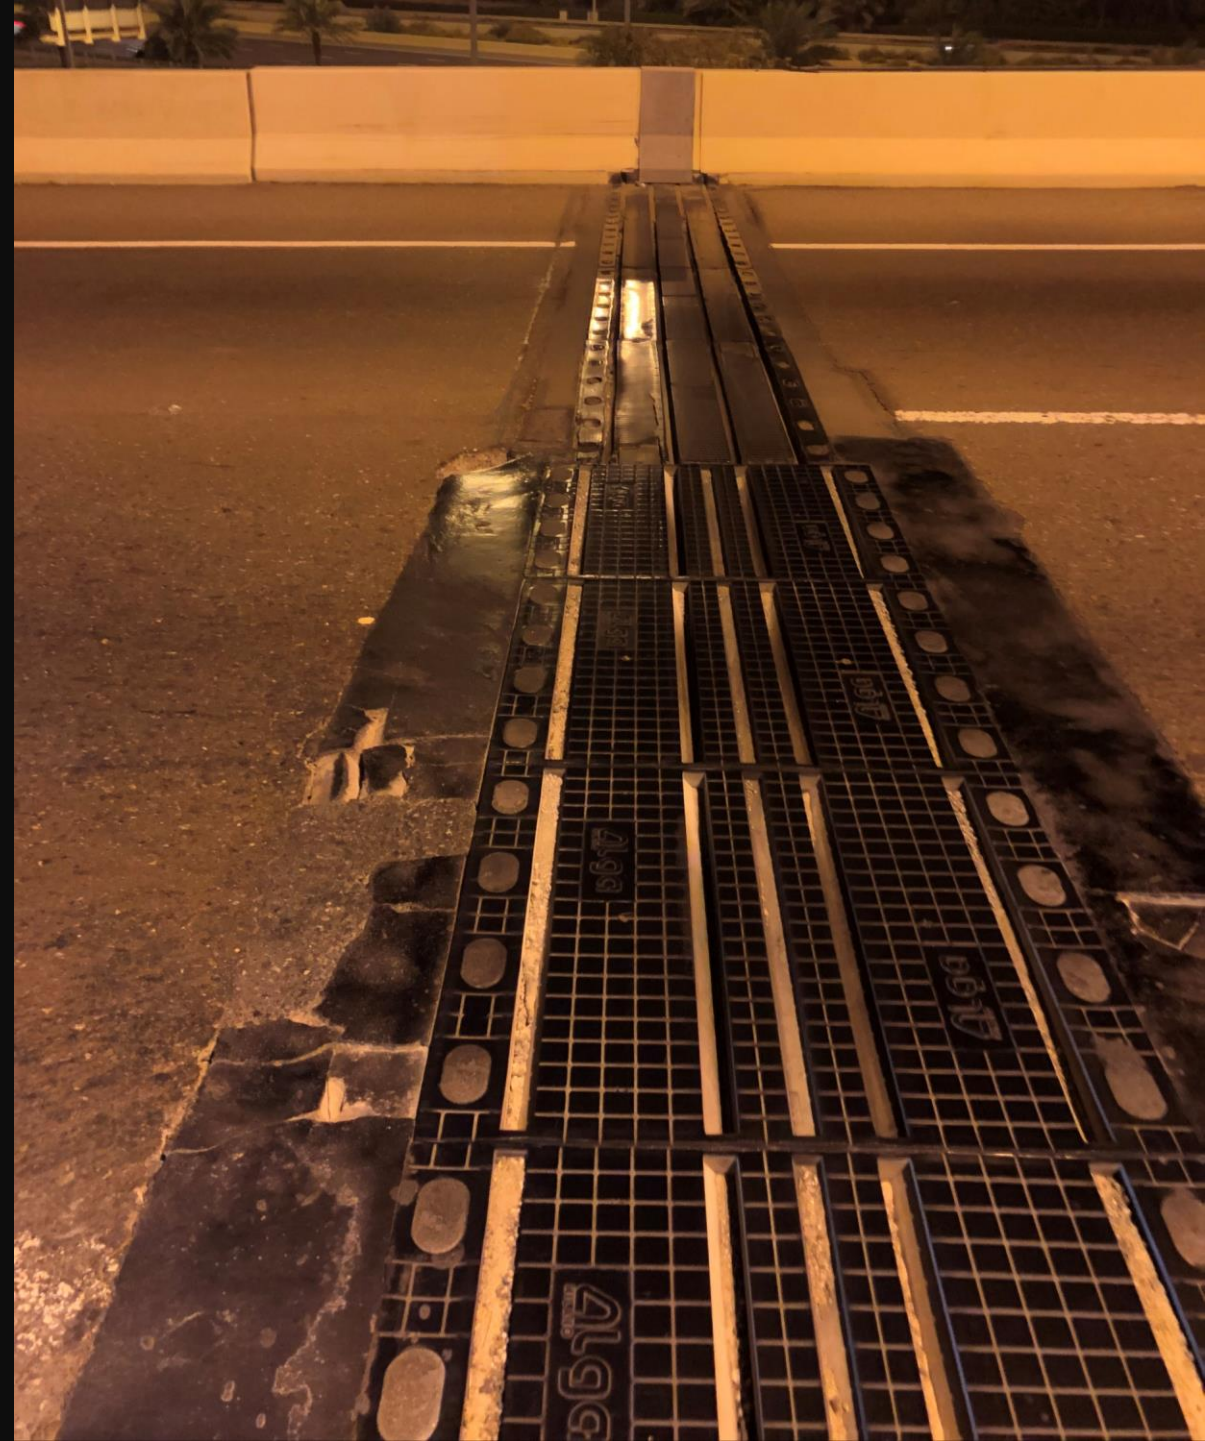
Breaking up or cracking of transition strips

- *This is generally caused by the transition strip becoming debonded, either from the surfacing or from the deck or abutment. Once debonded, the edge will be unsupported, and start to break up. This can happen to the transition strip and adjacent surfacing*
-

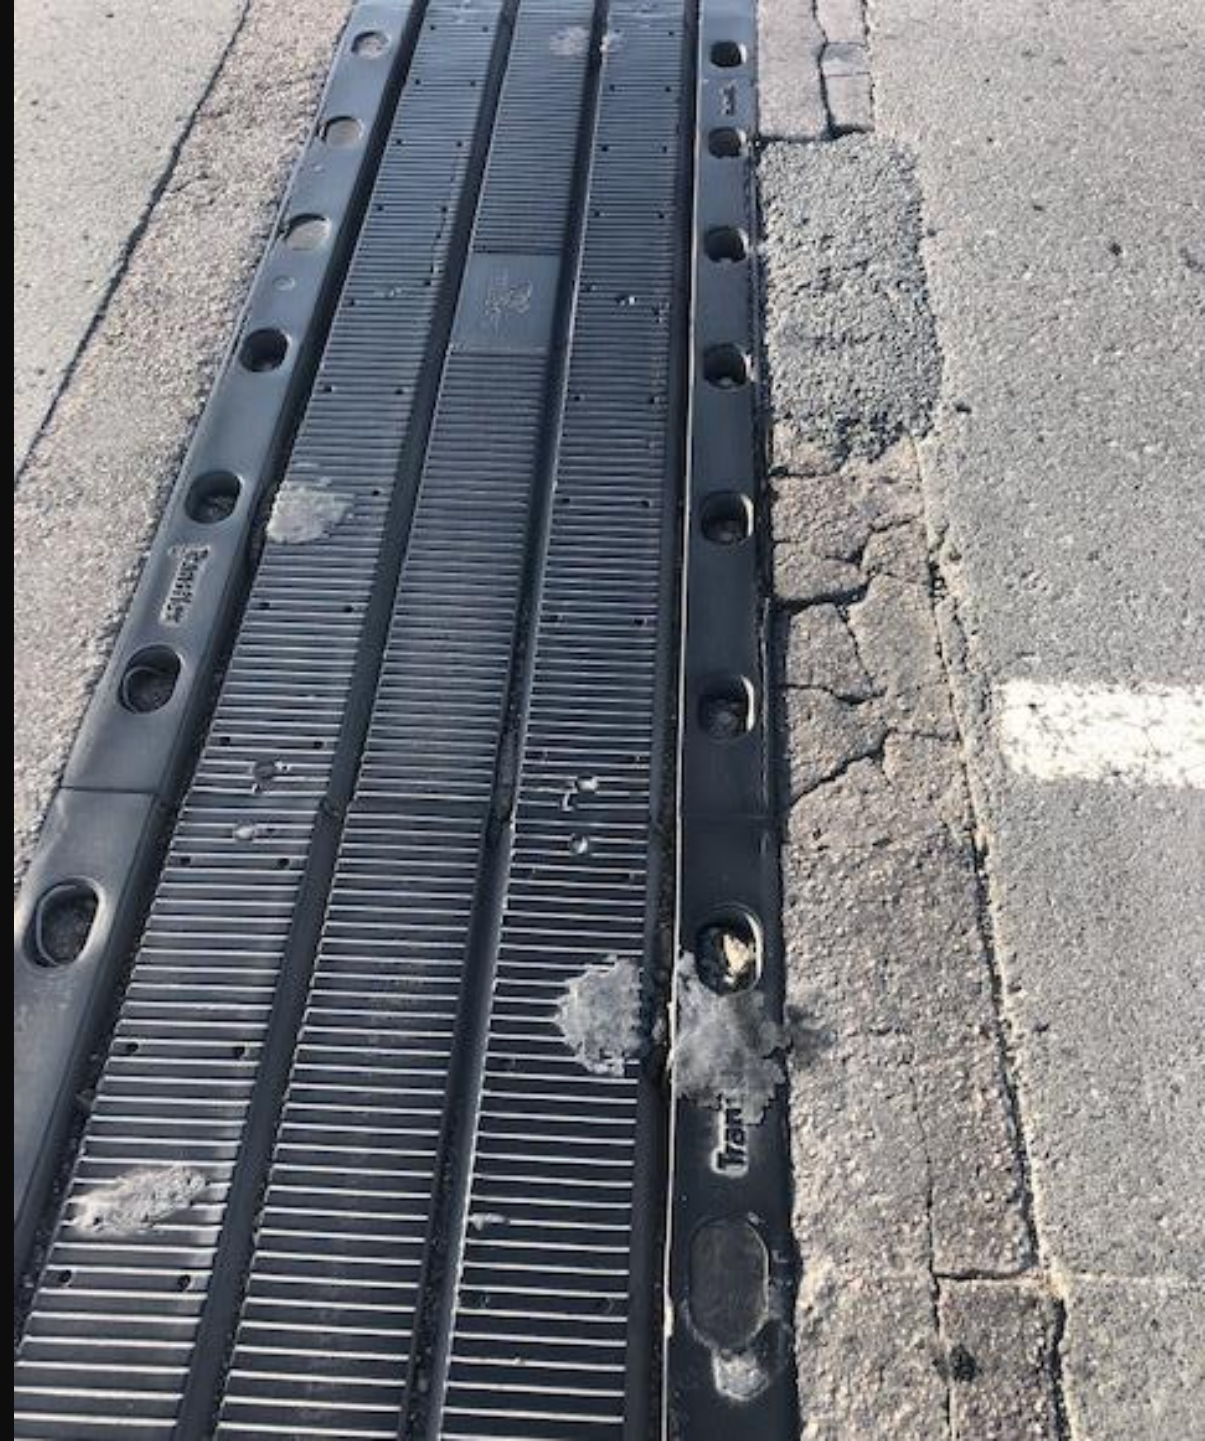
Missing bolt cover

- *The cover can be flicked out/removed by traffic, leaving the bolts underneath exposed. Corrosion of the bolts will lead to premature bolt failures*

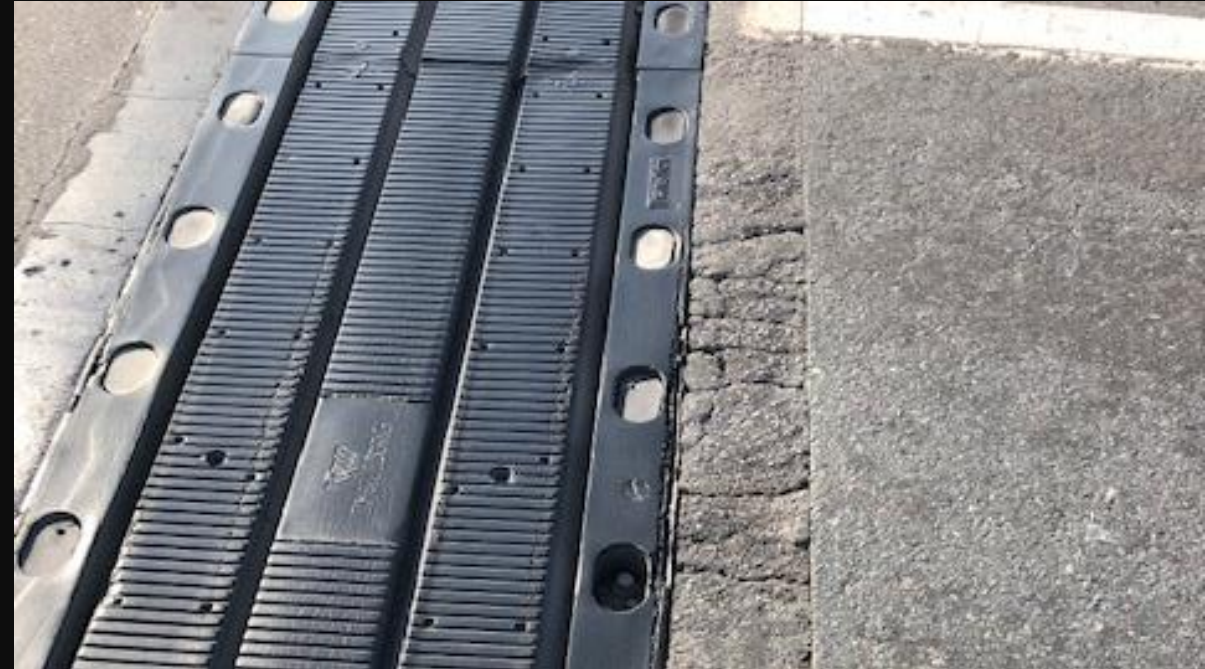
Loose bolts

- *This will lead to movement of the units, detected either through noise or visible under vehicles. This will lead to further bolts becoming loose.*

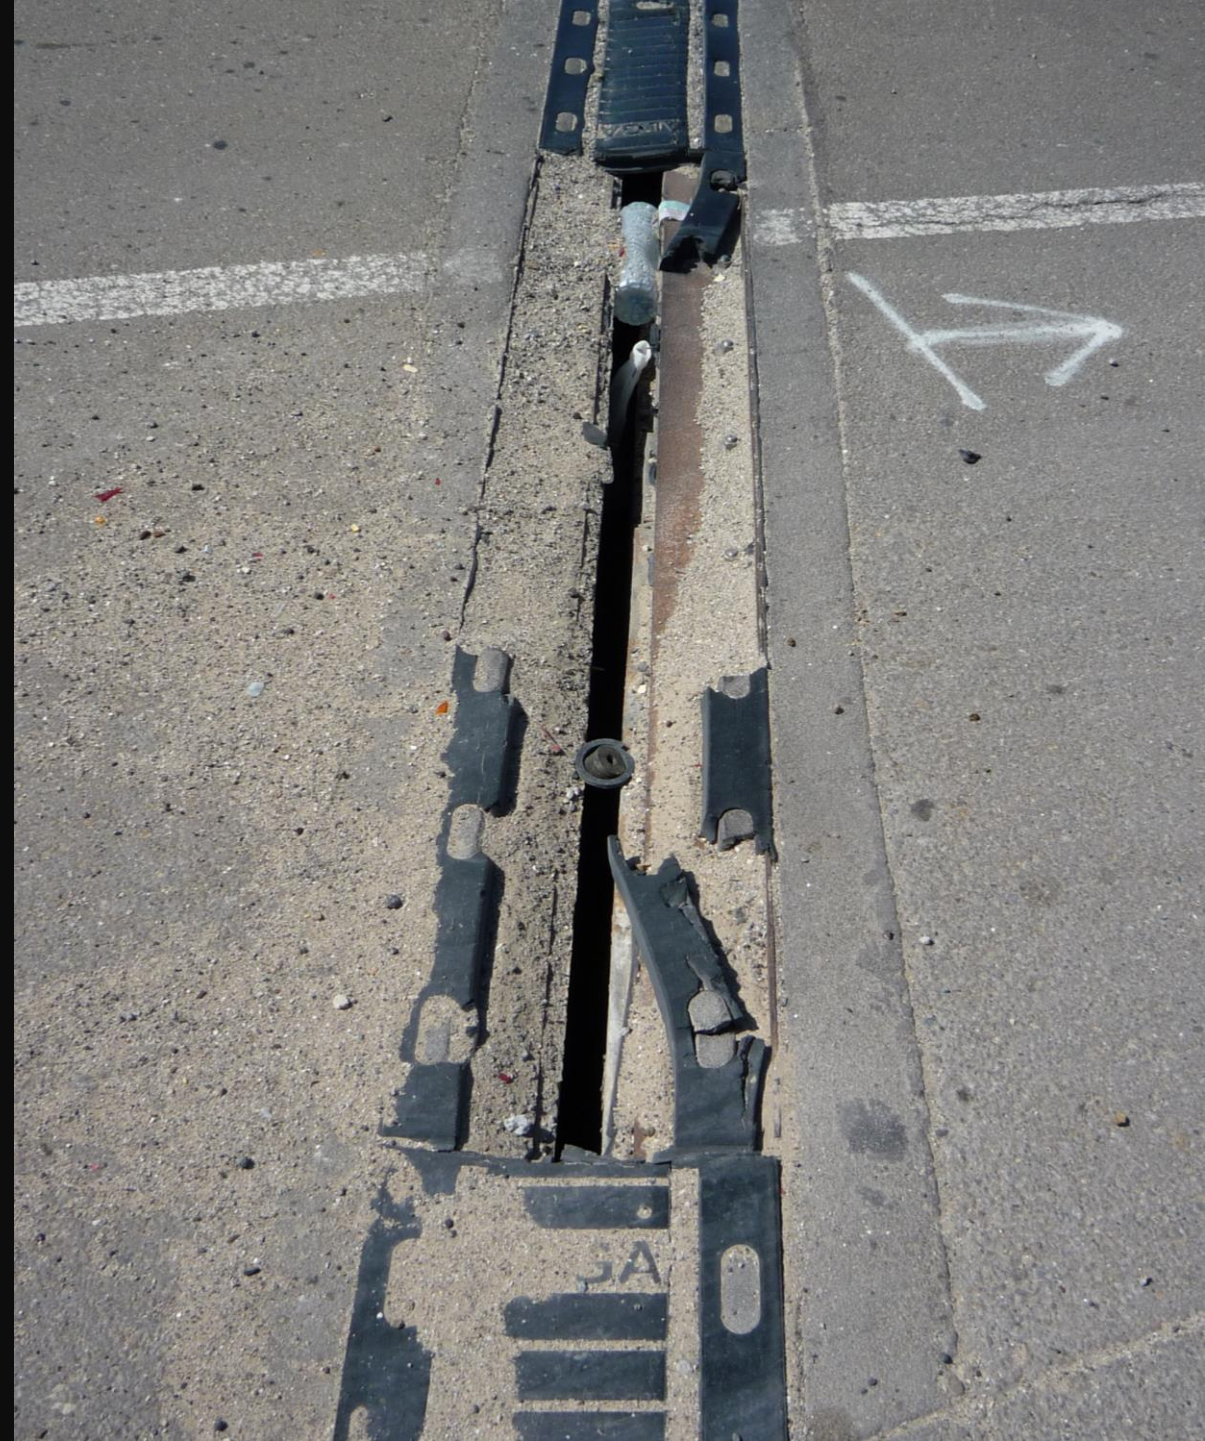
Bolt failures causing joint to lift

- *Sufficient bolt failures will cause the joint to move under traffic. This will lead to impact damage to the deck below the joint.*

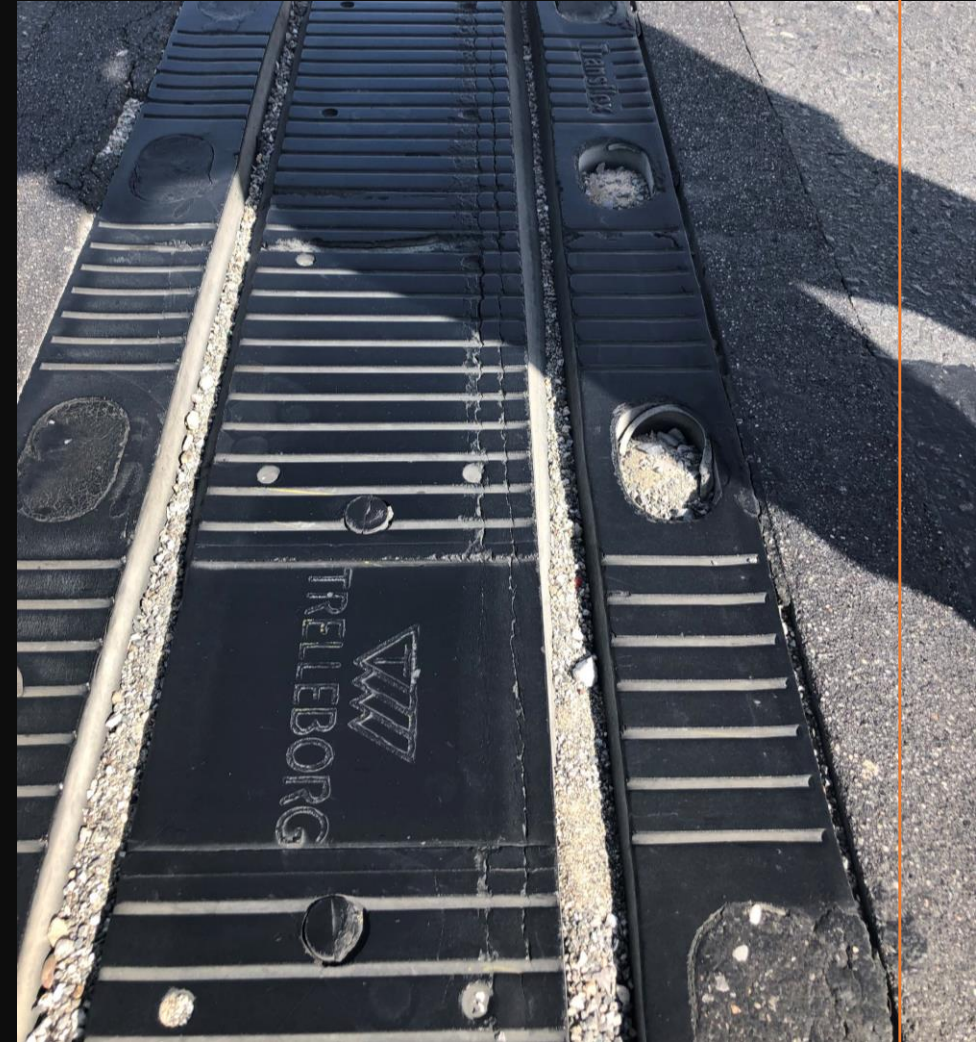
Debris in grooves

- *Debris in grooves will restrict movement and under vehicle pressure will wear the rubber.*

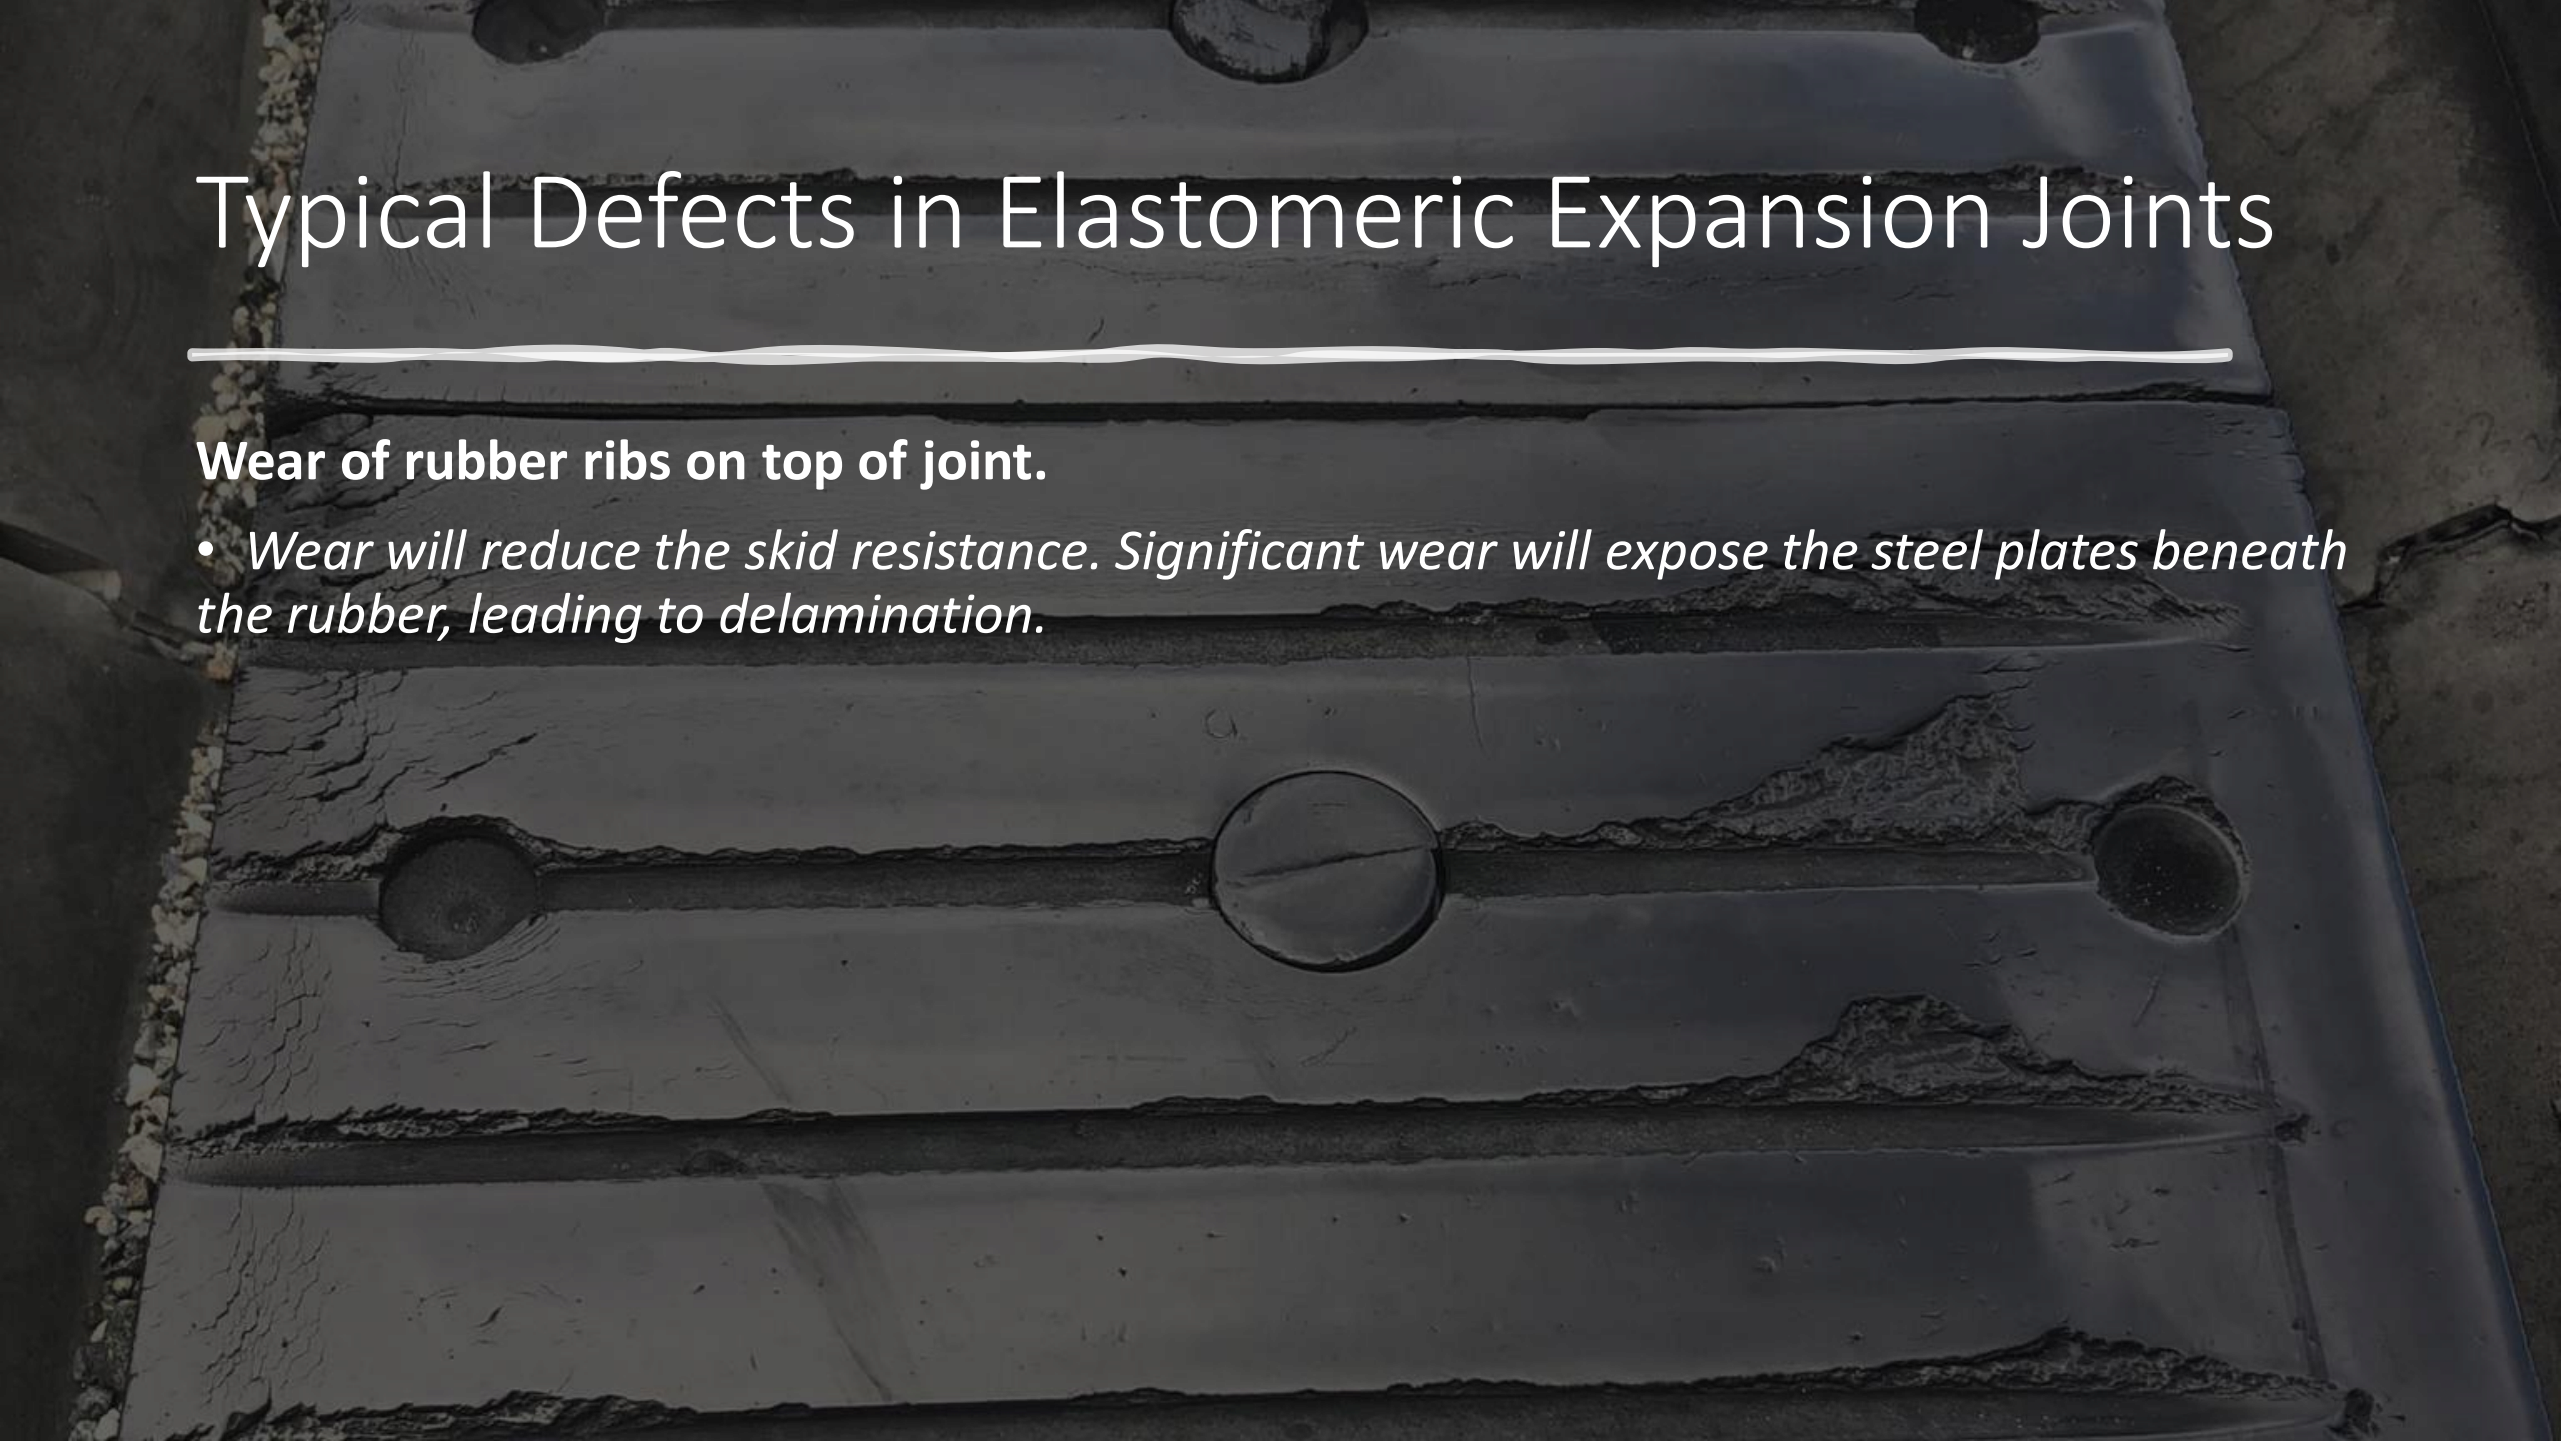
Wear of rubber ribs on top of joint.

- *Wear will reduce the skid resistance. Significant wear will expose the steel plates beneath the rubber, leading to delamination.*

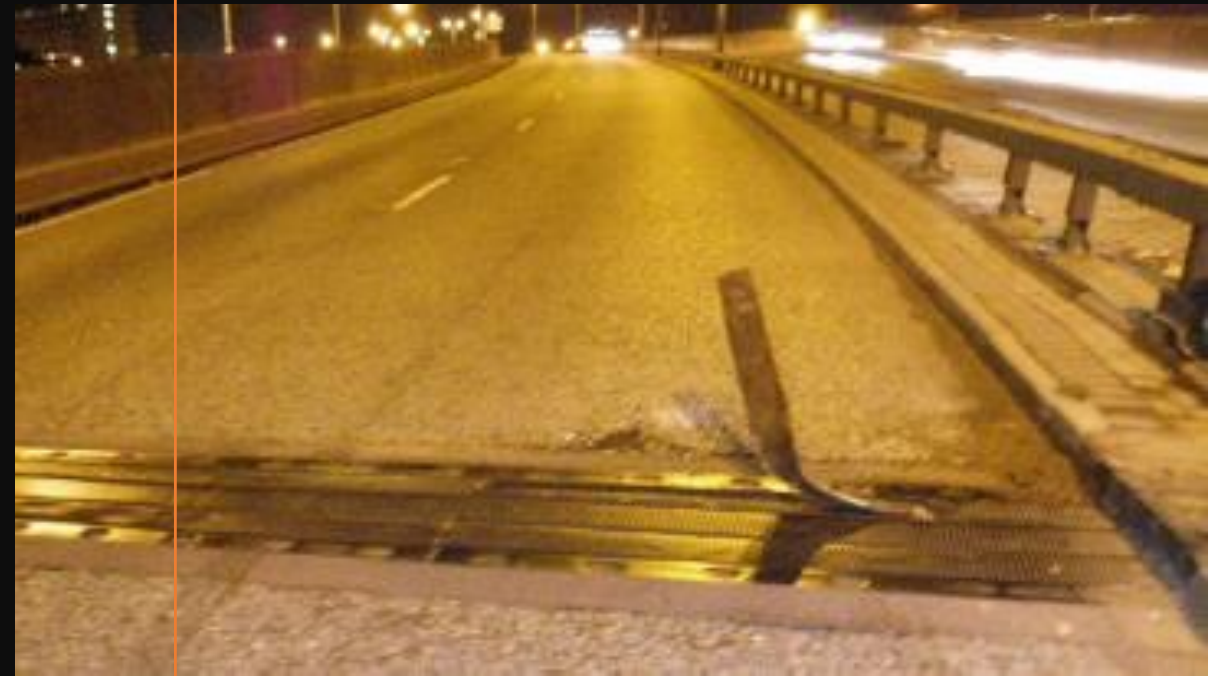
Delamination of elastomer/ metal plate interface

- *Heavy wear and tears in the elastomer will result in delamination, exposing the steel plate over significant areas of the joint. The metal is smooth, and so skid resistance will be limited. The exposed metal plate may also lift up, causing an obstruction in the carriageway.*

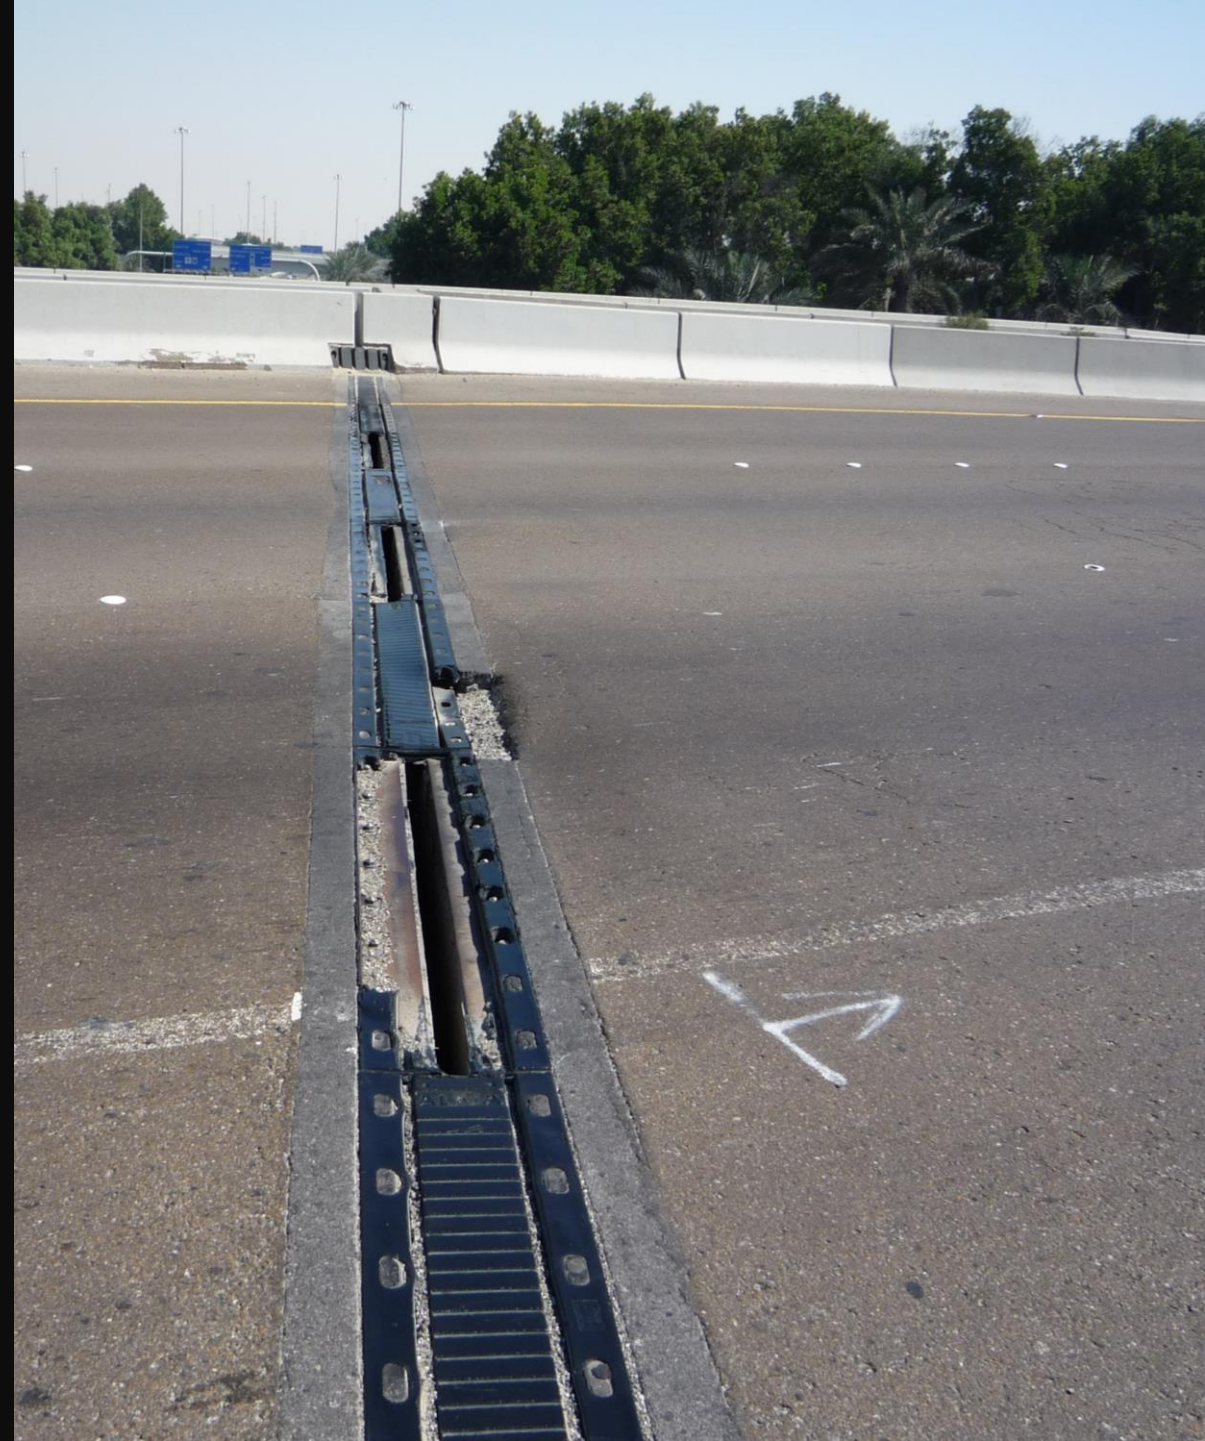
Leakage

- *This could be caused by any of the defects above, or failure of the drainage membrane. The effects could be damage to the carriageway either side of the joint, or early deterioration of the bridge structure*
-

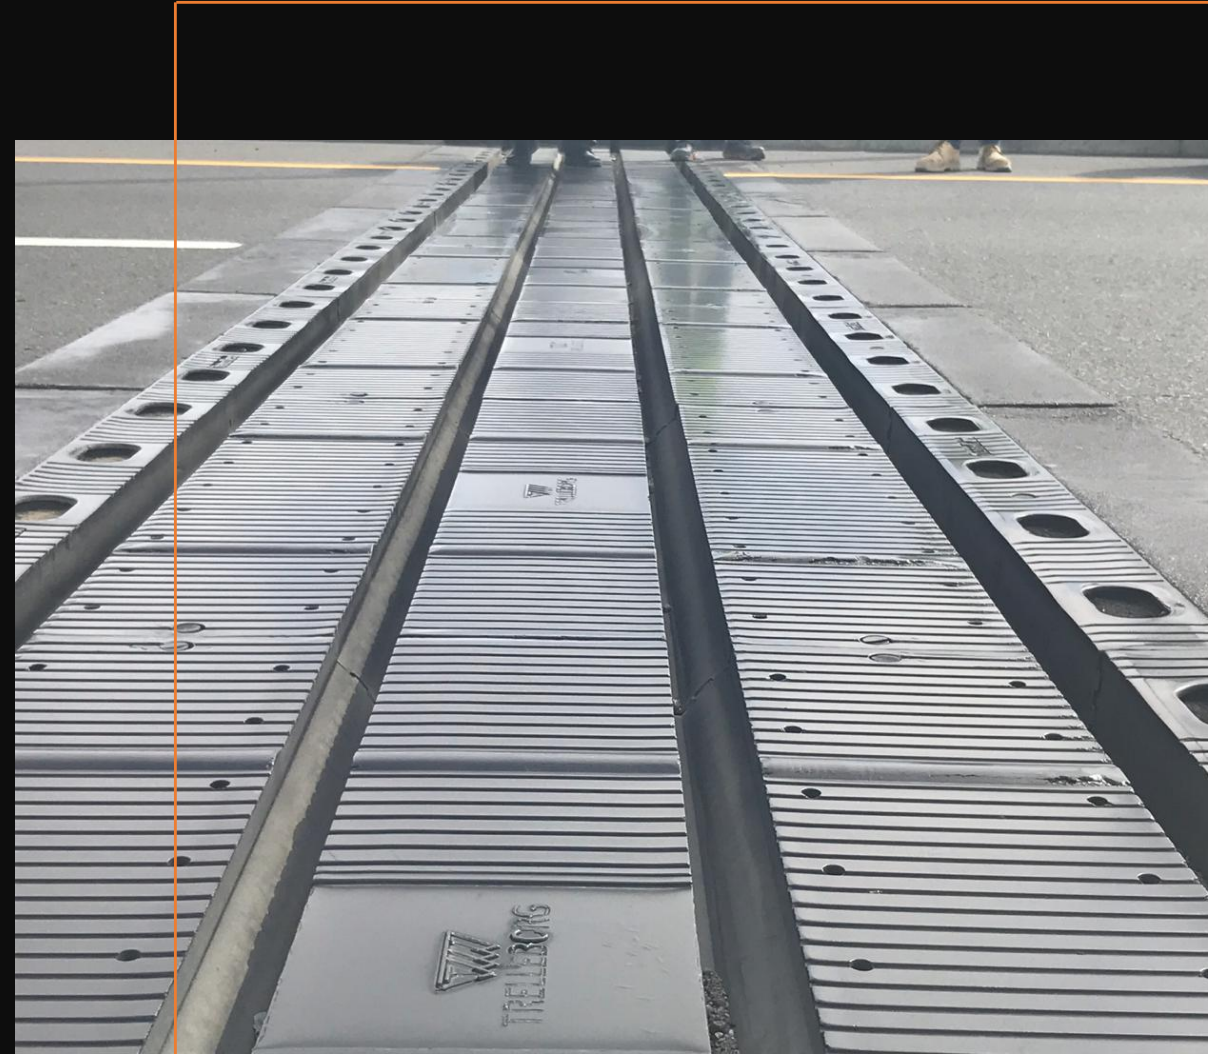
Sound

- *All joint components are in good condition, with no visible signs of defects. There are no cracks or tears visible.*

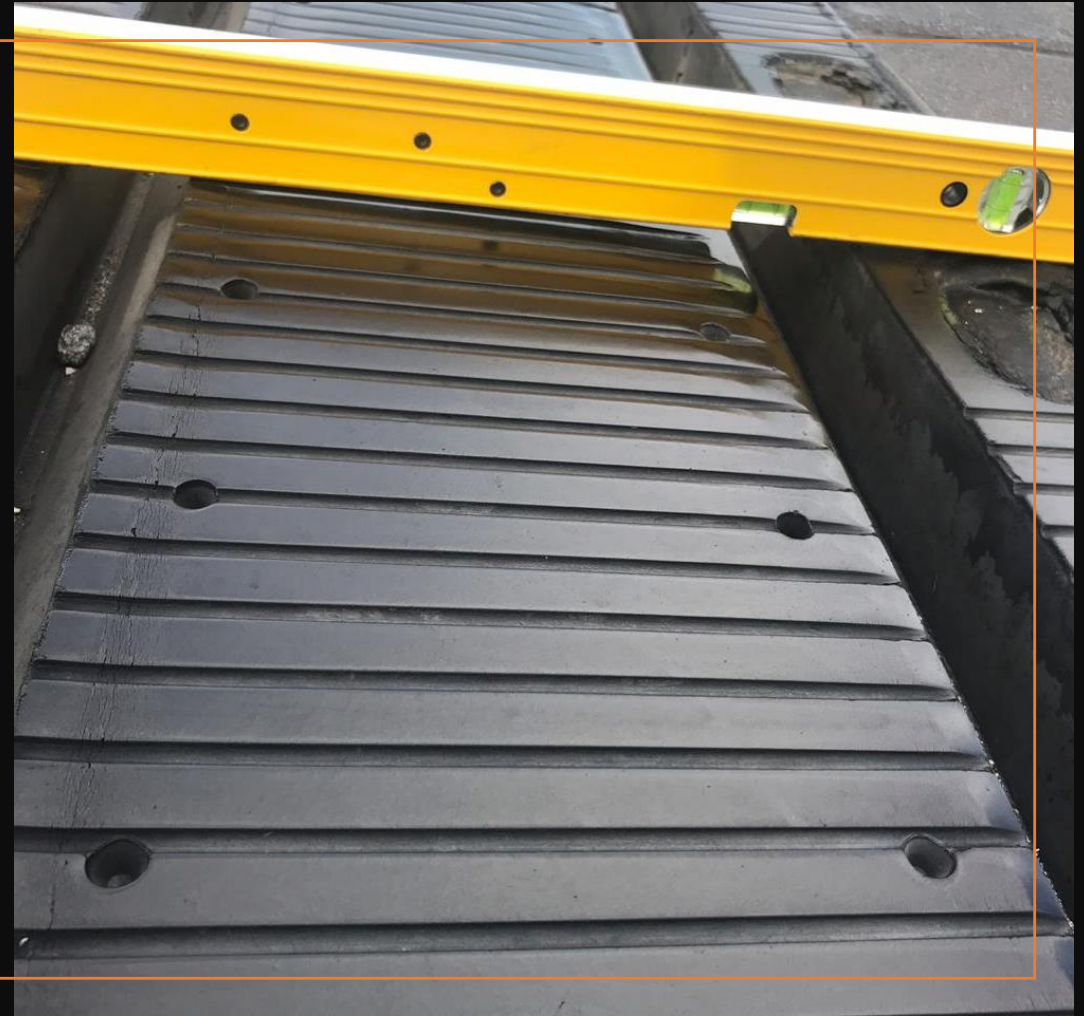
Initiation of cracking or tearing of components

- *Cracks or tears are visible. They are hairline and will require careful inspection to detect.*

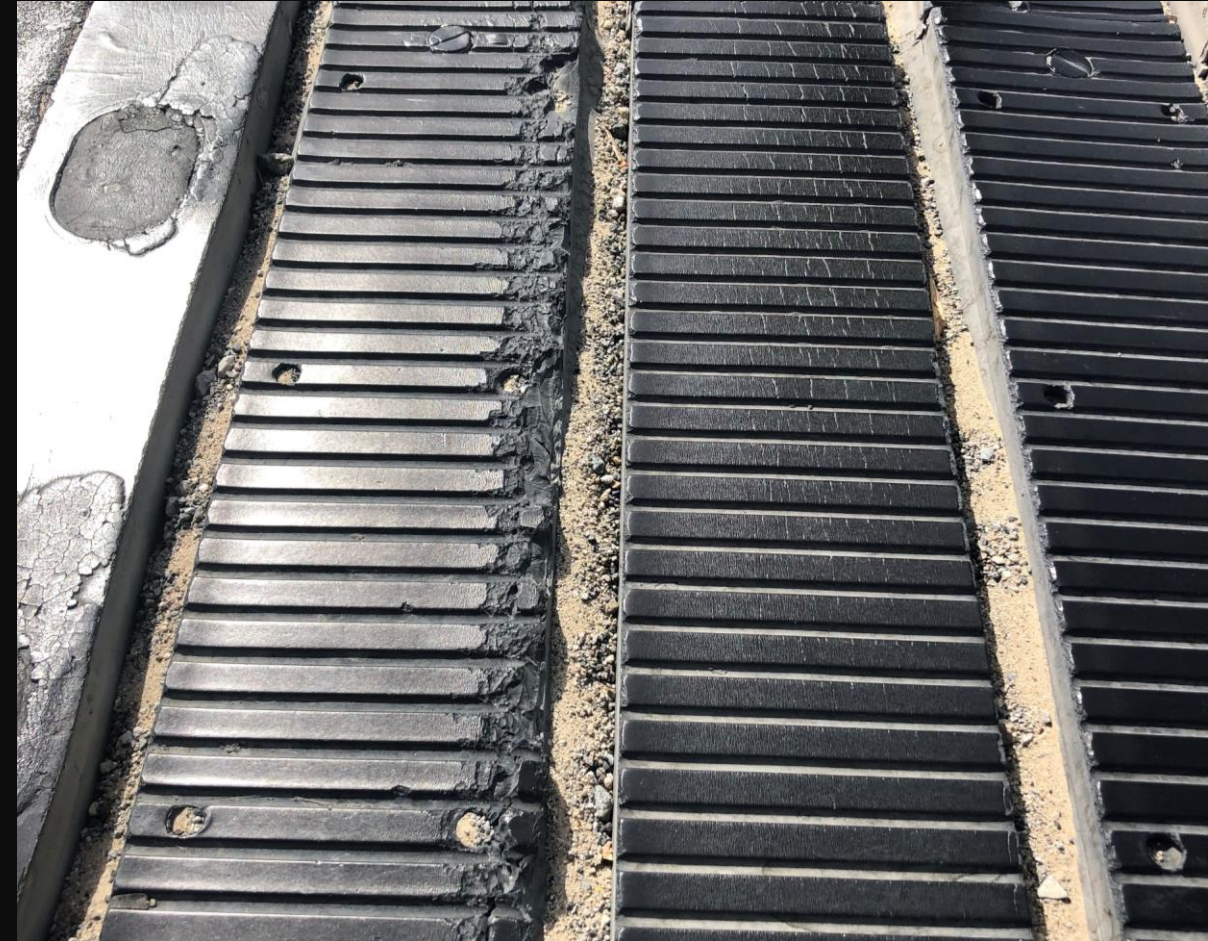
Crack/tear <20% of width of component

- *Cracks and tears are easily visible, but the joint is still able to function.*
 - this unit is in Project R842/2 (Junction 22, Bridge 4 – Abutment 1) . Although the joint is functioning properly, but the manufacturer will supply 13 units to RTA and determine the cause of this.
-

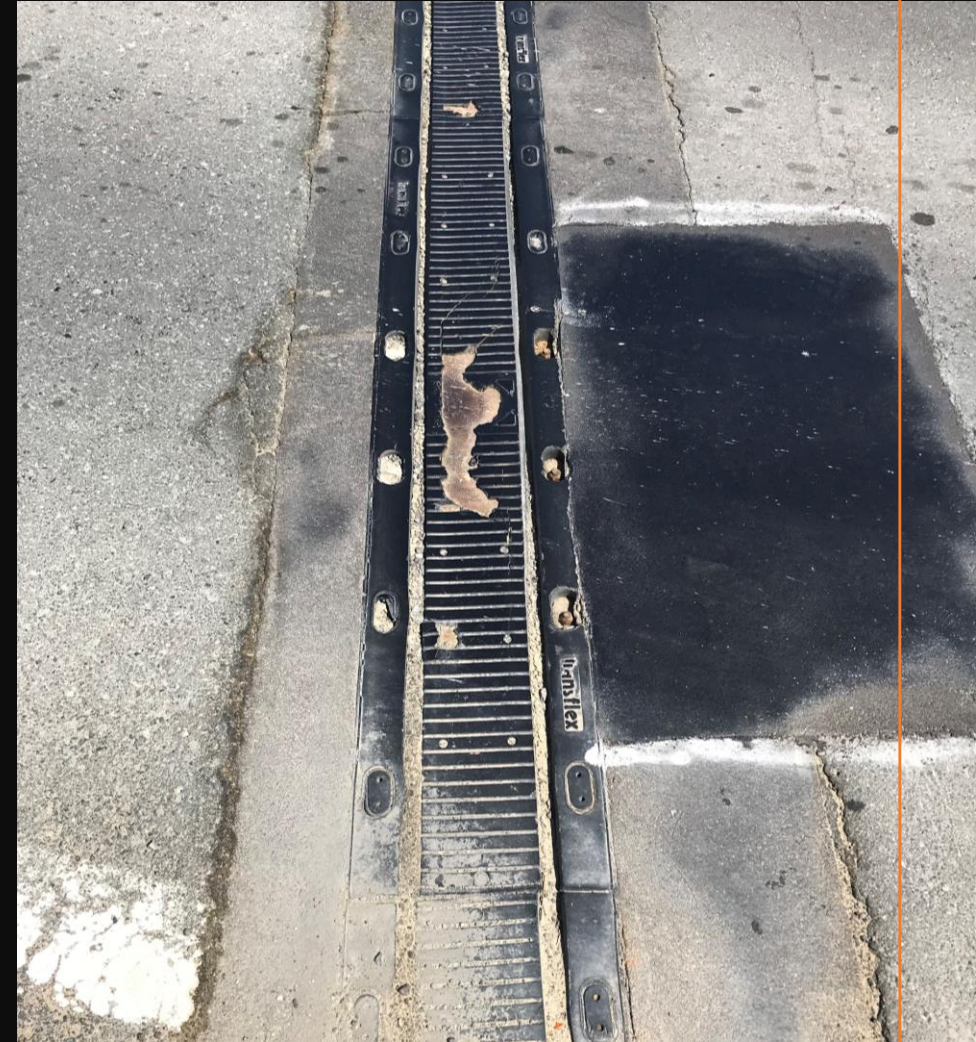
Crack/tear >20% by <50% of width of component

- *Cracks and tears are significant, but there remains some limited functionality. The steel in the plates is exposed. Complete failure can be expected shortly.*

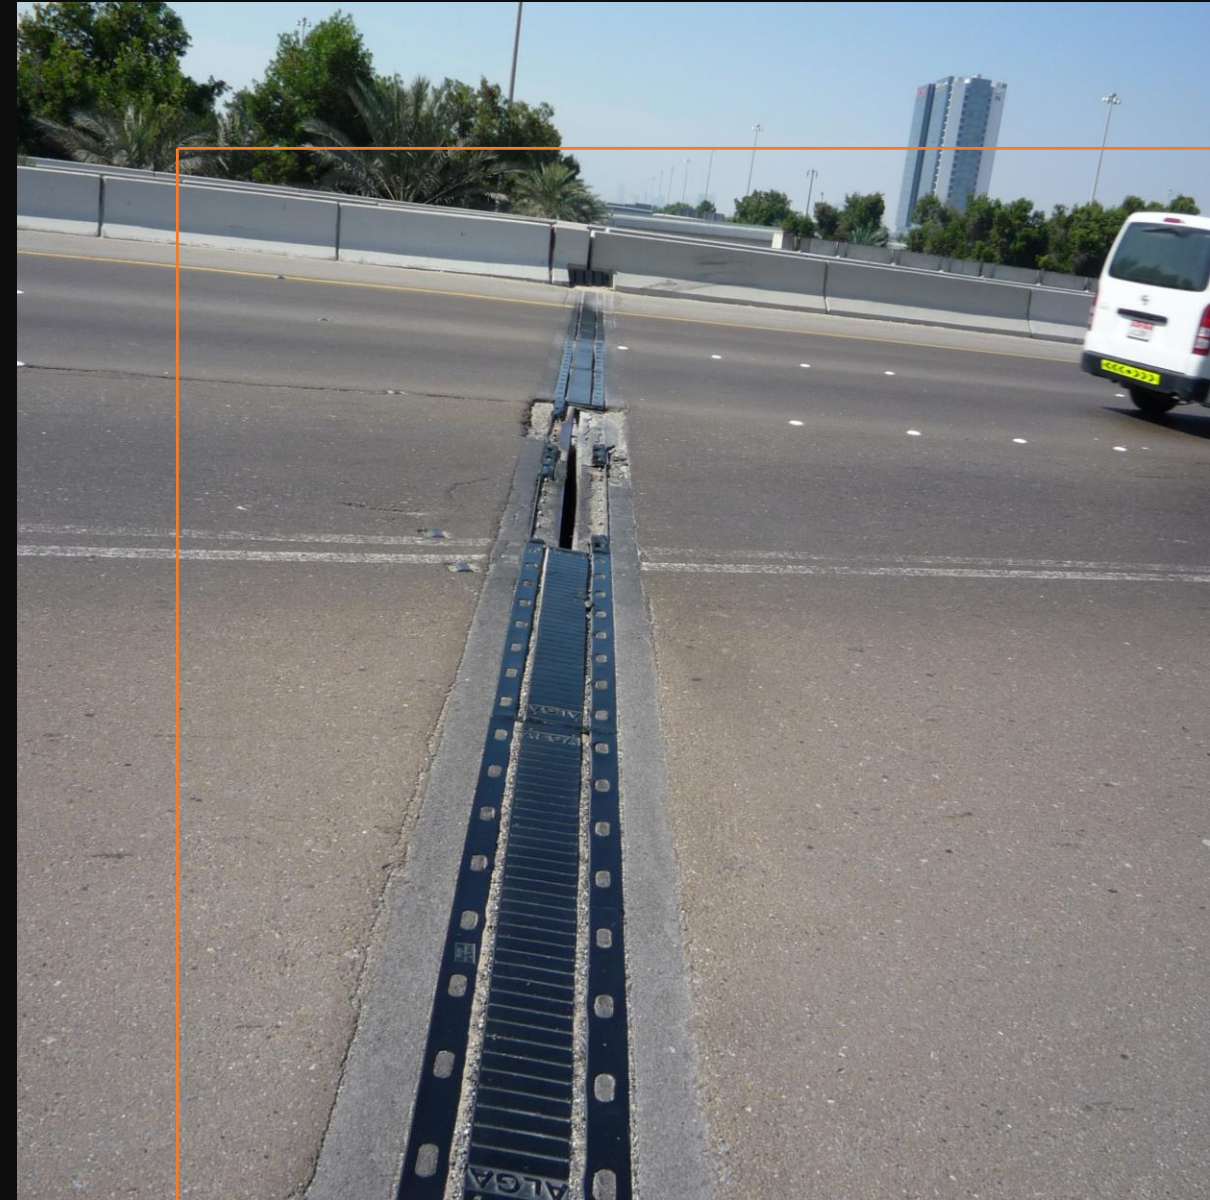
Failure of expansion joint component

- *A component of the joint has completely failed. Part of it has detached or is missing. A steel plate is loose or missing.*
